DEPARTMENT OF TRANSPORTATION**DIVISION OF ENGINEERING SERVICES**

Contract #: 04-0120F4Cty: SF/ALA Rte: 80 PM: 13.2/13.9File #: 1.28**WELDING INSPECTION REPORT****Resident Engineer:** Casey, William**Address:** 333 Burma Road**City:** Oakland, CA 94607**Report No:** WIR-027664**Date Inspected:** 29-May-2012**Project Name:** SAS Superstructure**OSM Arrival Time:** 700**Prime Contractor:** American Bridge/Fluor Enterprises, a JV**OSM Departure Time:** 1600**Contractor:** American Bridge/Fluor Enterprises, a JV**Location:** Job Site**CWI Name:** As noted below**CWI Present:** Yes No**Inspected CWI report:** Yes No N/A**Rod Oven in Use:** Yes No N/A**Electrode to specification:** Yes No N/A**Weld Procedures Followed:** Yes No N/A**Qualified Welders:** Yes No N/A**Verified Joint Fit-up:** Yes No N/A**Approved Drawings:** Yes No N/A**Approved WPS:** Yes No N/A**Delayed / Cancelled:** Yes No N/A**Bridge No:** 34-0006**Component:** SAS OBG**Summary of Items Observed:**

WELDING INSPECTION REPORT

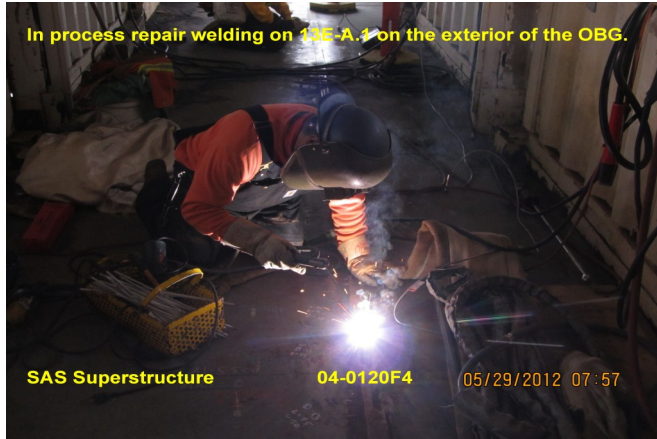
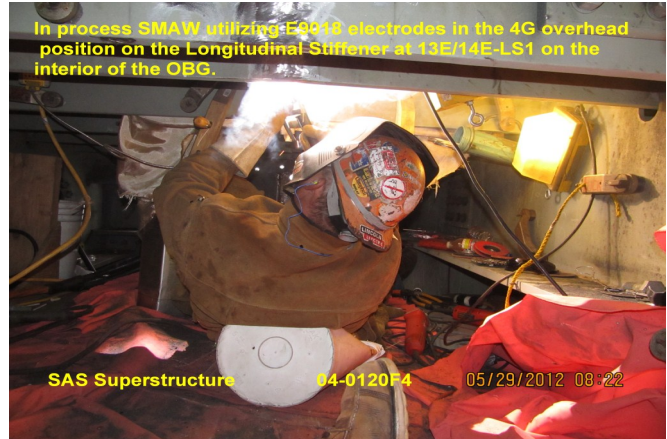
This QA Inspector randomly observed the repair welding operations performed by Three (3) ABF certified welders at the following locations. ABF welders Salvador Sandoval (ID 2202) at 13E-A.1 and 13E-A2.1, Jacob Stafford (ID 8020) at 13E-E2.8 on the exterior and Steven Davis (ID 7889) at 13E PP122.2 on the interior of the OBG placed the Pro-heat 35 thermal blankets over the welds to pre-heat to 110°C (225°F) prior to excavation with Carbon Arc Gouging (CAG). Upon removal of the discontinuities, QC Inspector Salvador Merino performed Magnetic Particle Testing (MT) to ensure soundness of the metal and it was observed that Mr. Merino found no relevant indications and recorded the dimensions of the excavations which are listed below. The welders were observed depositing metal by utilizing the Shielded Metal Arc Welding (SMAW) process in the 1G flat and 4G overhead positions respectively, employing 3.2mm E7018-H4R electrodes drawing amperage of 127 as pertaining to ABF-WPS-D1.5-1004-Repair. This QA Inspector verified that the electrodes were obtained from a baking oven at the correct temperature and within acceptable exposure limits. The welders were observed cleaning the start/stop edges of the work utilizing small disc grinders and compressed air and restored the base metal to the original surface and ground smooth, and the welds to their specific profiles. Post Weld Heat Treatment (PWHT) was applied to each completed weld surface at 230°C (450°F) for a period of 1 hour in accordance with Section 12.15 of AWS D1.5-2002. The repairs were completed on this date and appeared to be in general conformance to the
